Minerals Inspection Report

Mine Name: United Stone		Permit Number:	S470079	Mine Status:	Forfeiture
Operator Name: United Stone and Design		Inspection Date:	05212014	Permit Fees:	No Fee Req.
Inspe	ector(s): A. Abate	Inspection Time:	0900 AM	Bond Amount:	\$3,900
Atter	ndee(s): A. Jiron	Weather:	Clear	Bond Escalation:	
Inspe	ection Purpose: Check on the status of the clean up	activity at all stone sites		Prior Inspection:	05/06/2009
Site v	clusions and Recommendations work is being completed by Mr. Ab Jiron, a local st ng the former United Stone sites cleaned up. Availa ts, or for additional seed mix.	able funds could be put towa	rd either compen	sating Mr. Jiron for the r	reclamation
	Elements of Inspection			valuated & Commented	Enforcemen

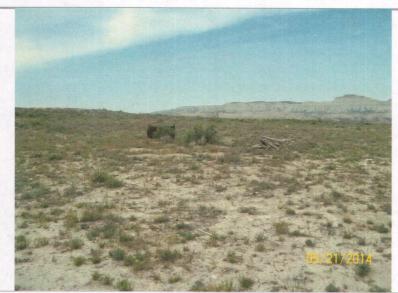
Site 1: Stone is being cleaned up. New vegetation growth is present. According to Ab, the clean up here was the worst site of all.

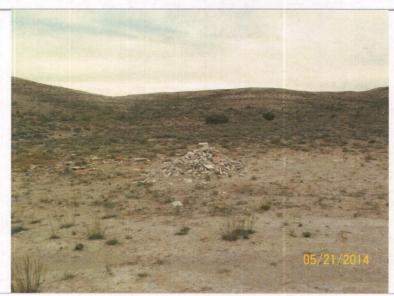
Site 1: Small piles are all that remain. Ab is actively cleaning this rock up and palletizing it for shipment.

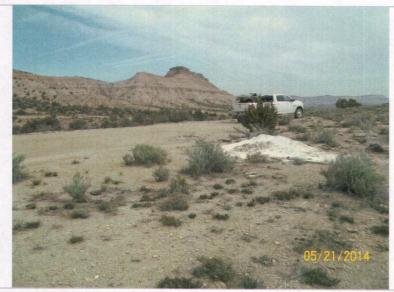
Site 2: Reported barrels and trash at this site are cleaned up. Flat staging area will remain for the gas company.

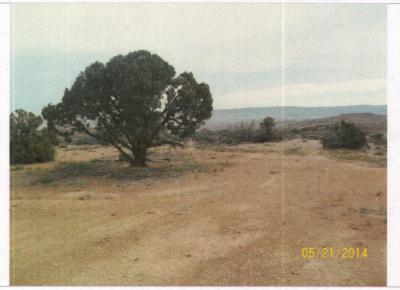
Site 4: Former camp area. Trash and tents have been cleaned up. Ab will reclaim the road from here to Site 5.

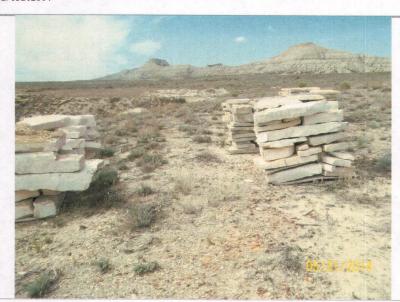
Site 5: The ledges still had some debris in the area. Stone was being organized into piles.

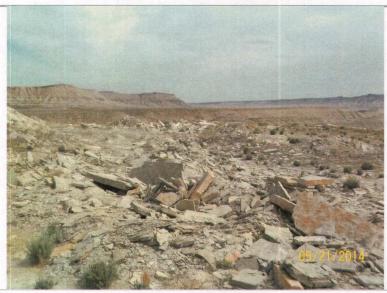
United Mess: This was the worst of the sites I saw. The plan is to reclaim in June 2014.

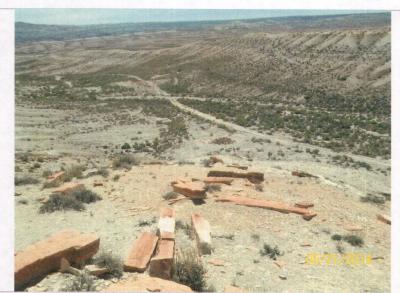
Stone was laying on the ground naturally in some areas such as this.

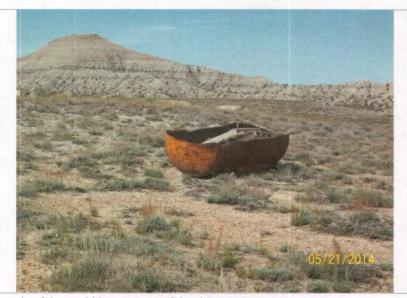
An example of the steel bins on some of the sites.

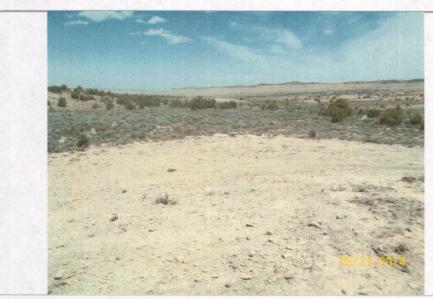
Site 7: Photo of the grading work

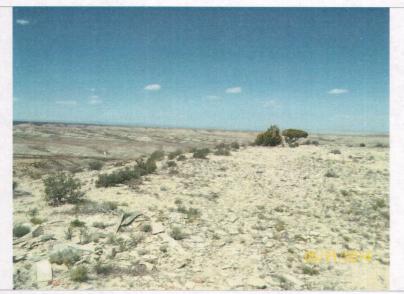
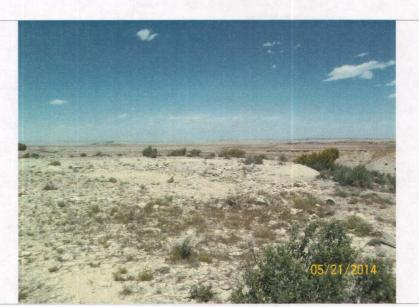
Site 8: Panoramic (photos L and R) Vegetation is beginning to grow.
